Subject: June 21-22, 2017 Compliance Evaluation Inspection

**CWA COMPLIANCE EVALUATION INSPECTION REPORT  
U.S. ENVIRONMENTAL PROTECTION AGENCY, REGION 5**

Central Sands Dairy, LLC  
15918 County Road G  
Nekoosa, Wisconsin 54457  
Juneau County  
44.22N, -89.97W

ATTACHMENT A: PHOTO LOG

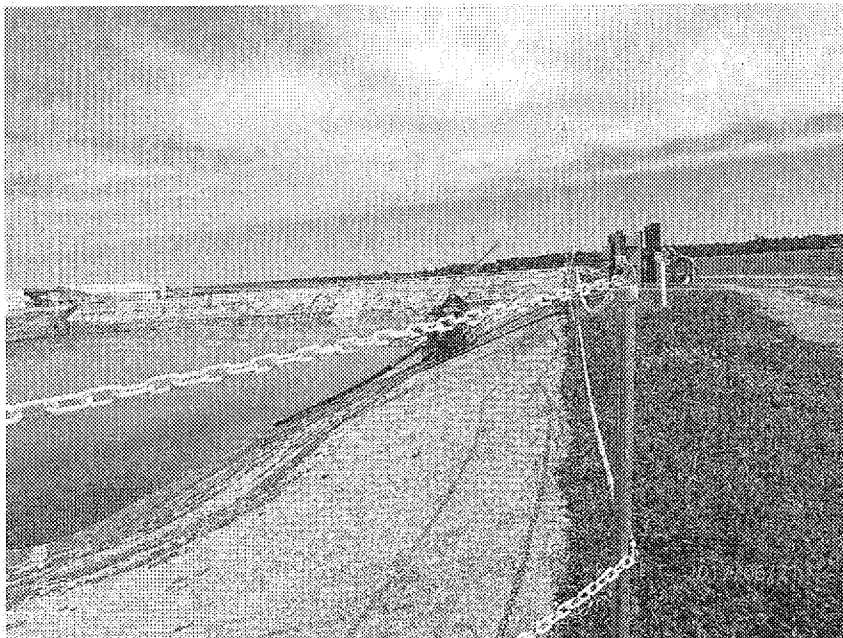
3: P6210156

Description: Arrow depicts the pumping unit, on the east bank of the manure storage lagoon.

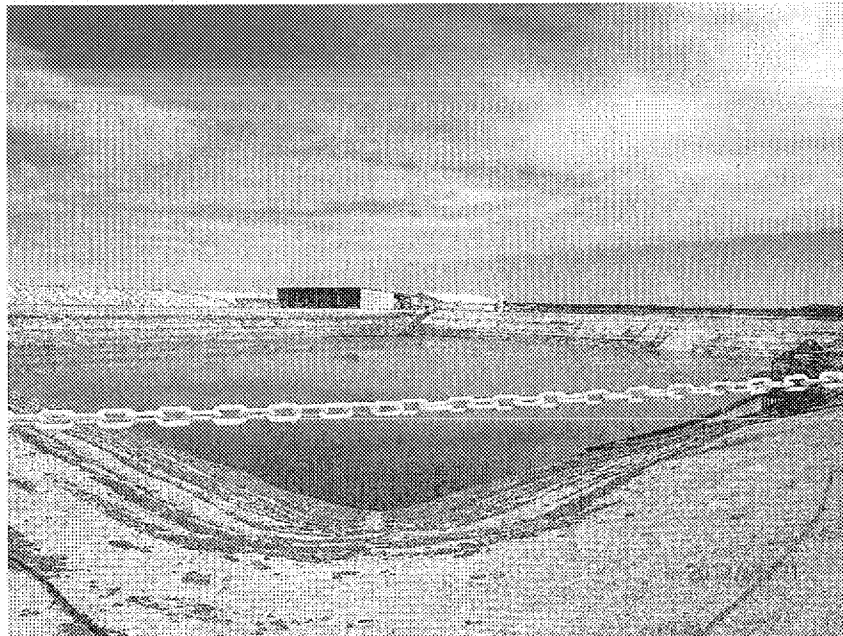
4: P6210157

Description: Manure storage lagoon.

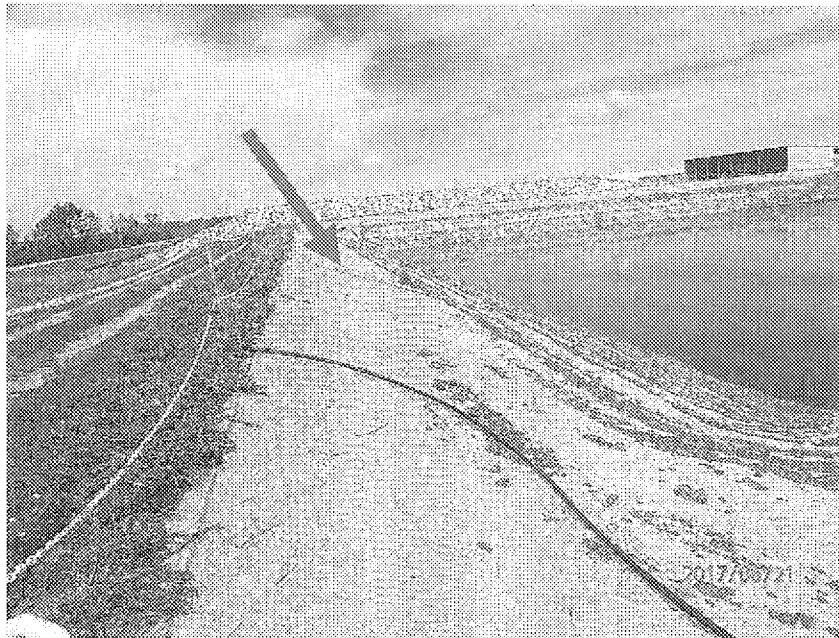
6: P6210159

Description: The red arrow shows the MOL marker on the south bank of of the manure storage lagoon.

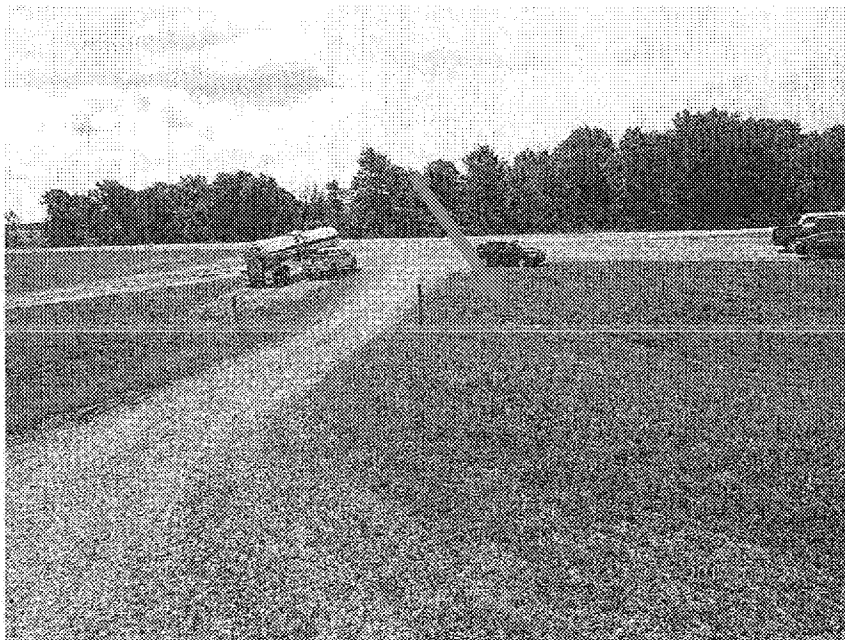
7: P6210160

Description: Looking east of the manure storage lagoon the red arrow points to where there is a drainage pipe under the dirt road for the manure storage lagoon that allows storm water to flow into the vegetated depression area on the south side the manure storage lagoon.

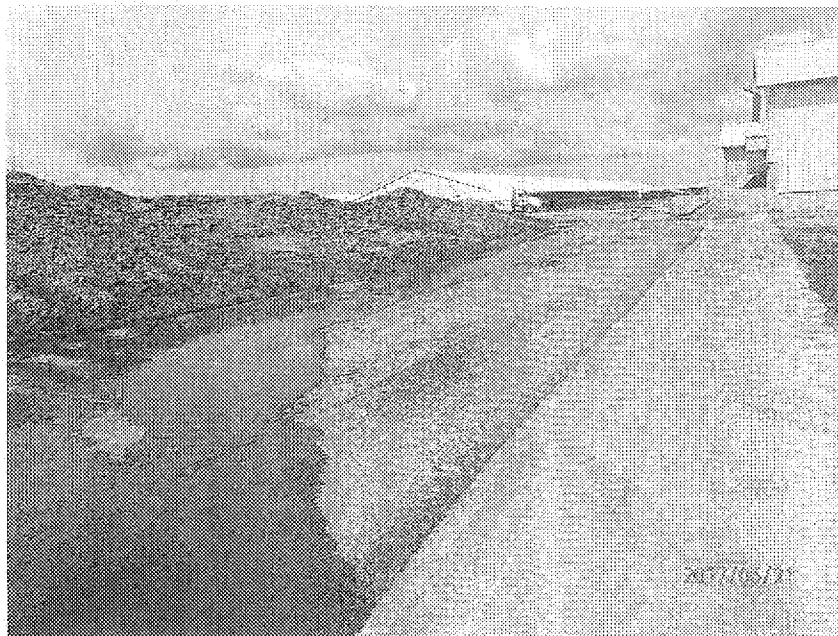
30: P6210183

Description: Area draining to the manhole in photo 29 above.

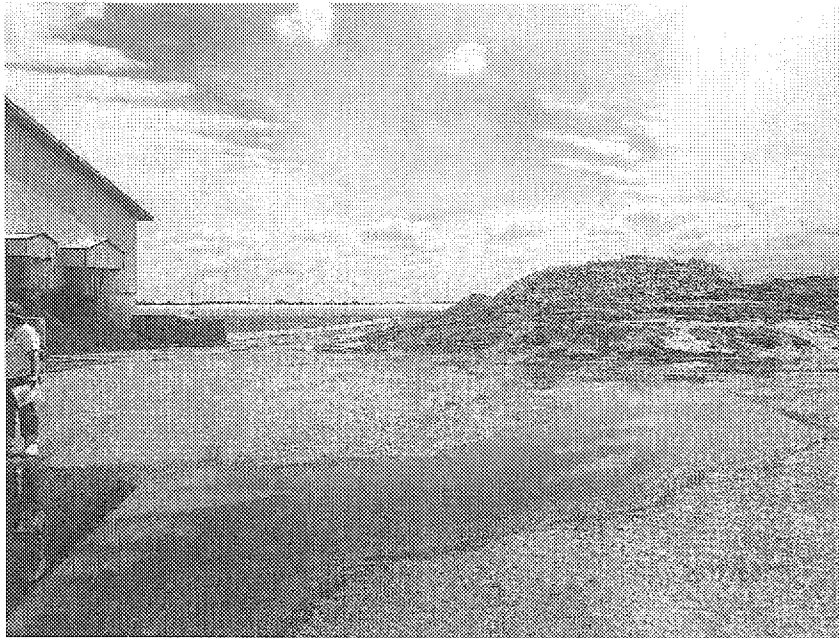
33: P6210186

Description: Sand storage area in front of the sand separator building. Process water flows east.

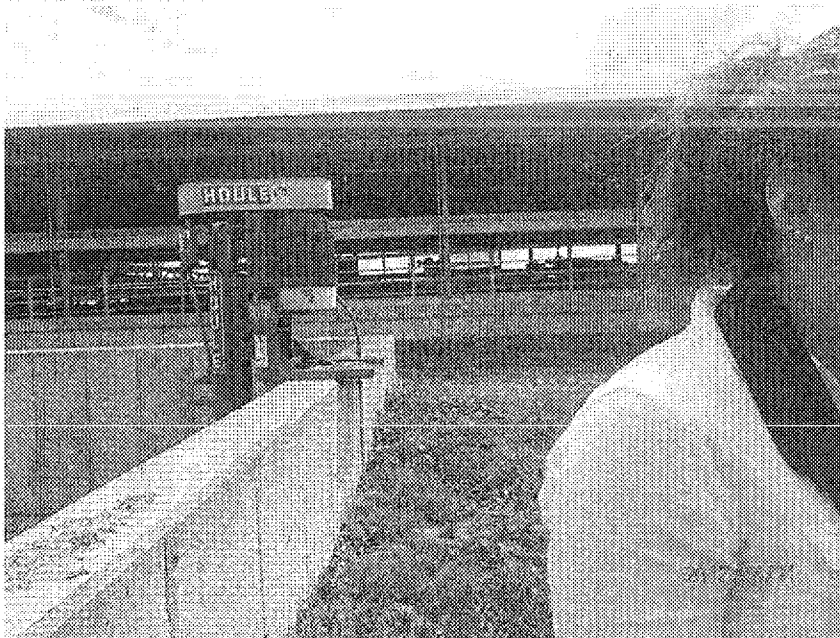
56: P6210209

Description: Pit between the south barn and the milking parlor. South pump used to flush out the milking parlor.

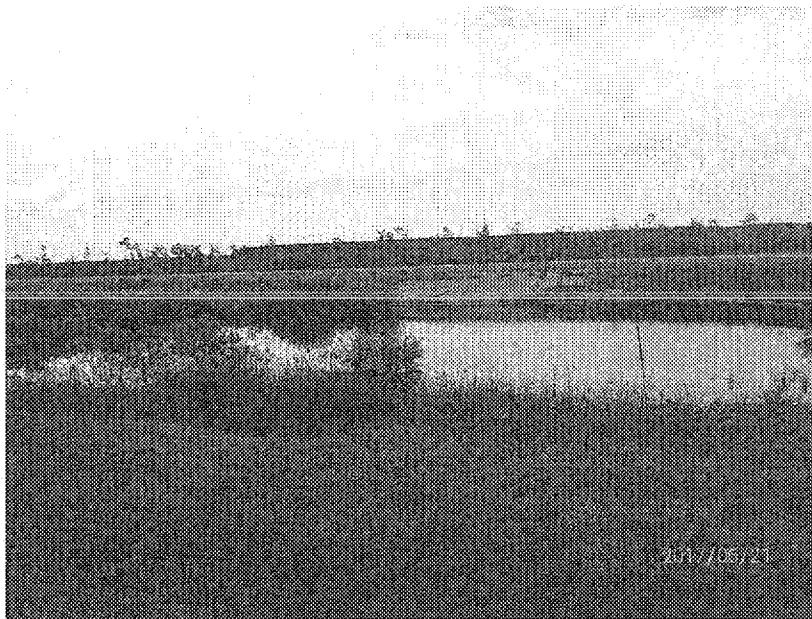
59: P6210212

As EPA was walking around Stormwater Pond 1 and Stormwater Pond 2, EPA did not observe process wastewater from the barns or silage pads entering the stormwater ponds. EPA was told by CSD that water within the stormwater ponds infiltrates into the ground (P6210212 through P6210220). EPA walked through the silage bunkers located east of Stormwater Pond 2 and west of manure storage lagoon. The silage bunker is bermed and the pit that collects the leachate had some feed on top of the pit and leachate from the silage was on the outside of the pit (P6210221 through P6210224). However, any process wastewater from the silage bunker that did not make it into the pit flowed into the engineered grass depression where it was designed to infiltrate into the ground. The walk-through of the production area ended at monitoring well CSD-5. EPA then walked back to the office at approximately 12:00 PM.

Description: Stormwater Pond 1 on the south side of the milking parlor. It receives rain water runoff.

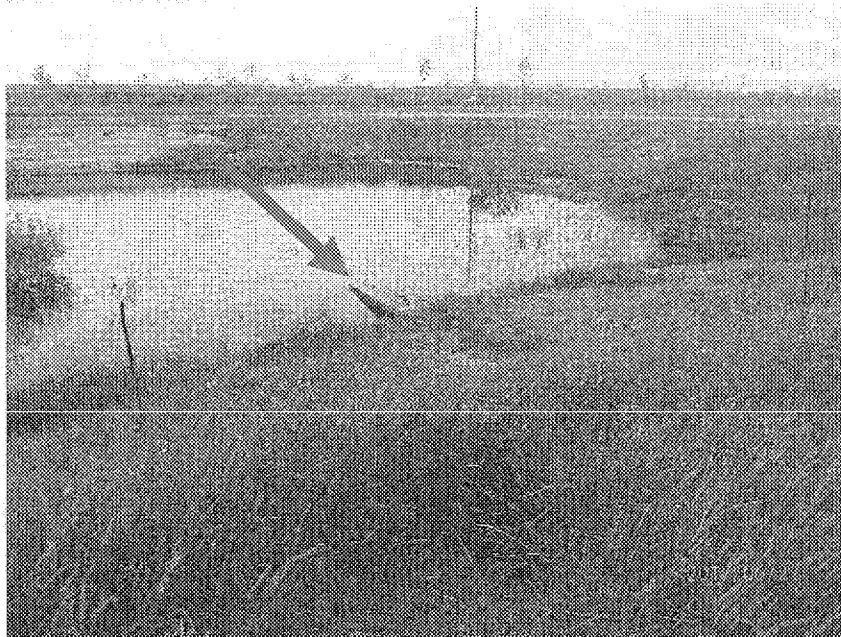
60: P6210213

Description: Pipe in Stormwater Pond 1 (aka Stormwater Pond – west) comes from the milking parlor roof gutters.

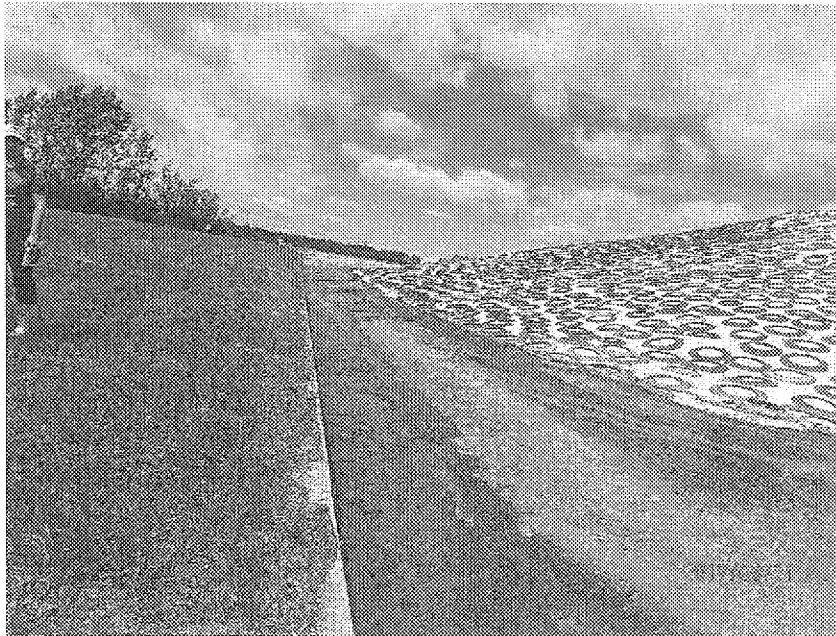
70: P6210223

Description: Runoff collection area south of the feed storage area that directs runoff towards the pit in photos 68, 69.

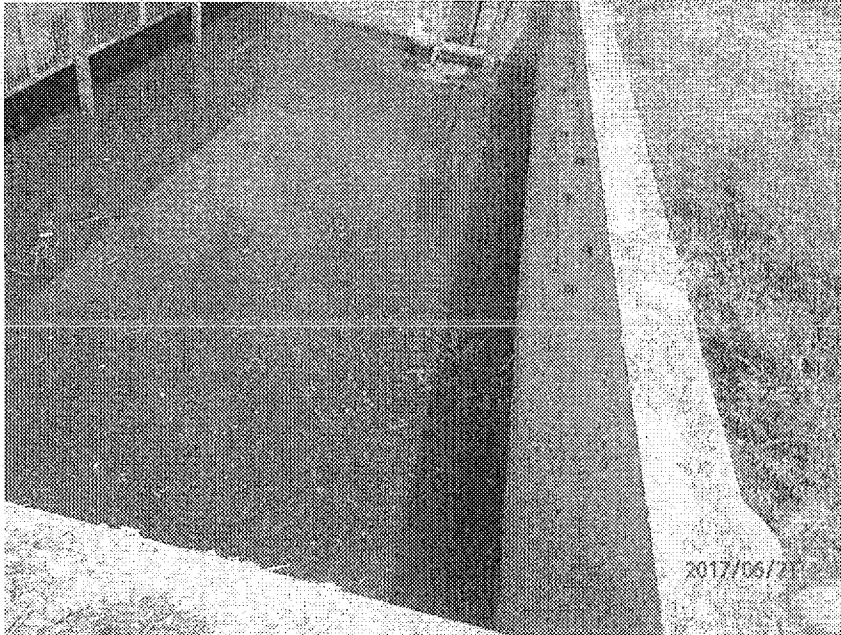
71: P6210224

Description: Pit that receives runoff from the feed storage area.
